Experimental Evaluation of
the Corrosive Potential of
Flux Residue Cleaning Agents

NEWARK AIR FORCE BASE

January 31, 1992

J. T. Stropki and G. O. Davis

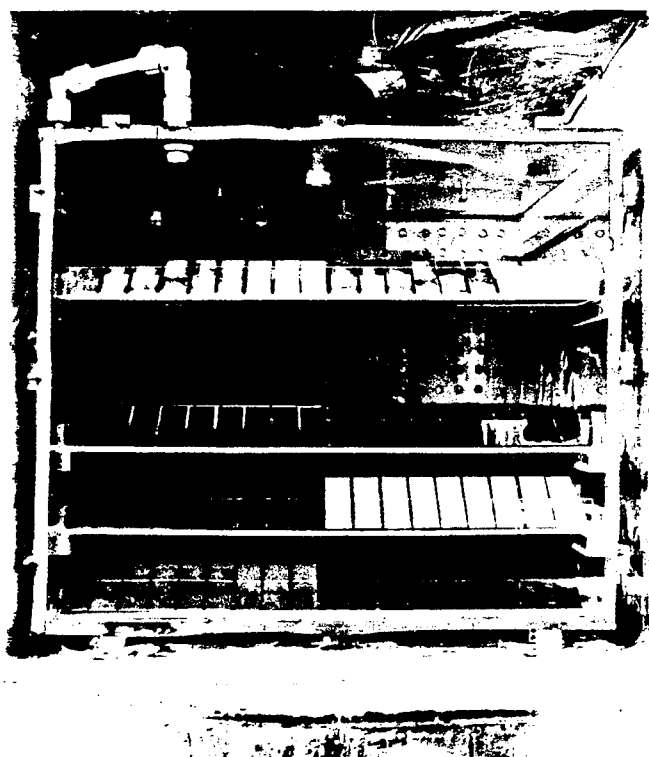
**FIGURE 2. PHOTOGRAPH DOCUMENTING PLACEMENT OF TEST SPECIMENS
AND SPECIMENS RACKS WITHIN ENVIRONMENTAL TEST CHAMBER**

All specimens were loosely mounted, at an angle of 15 degrees from vertical, within fourteen separate Plexiglas® specimen holders. This angle was selected to minimize the possibility of condensate collection along the coated surfaces of the specimens. Each rectangular-shaped holder was 21 inches long, which allowed Battelle technicians to mount a total of 18 specimens into a single holder. In most instances, six sets of triplicate specimens were positioned within each holder and loaded onto several racks located throughout the environmental test chamber. A spacing of approximately 0.125 inch was maintained between all specimens during the 1-month test exposure period. Identification labels for each specimen were affixed to the front lower surfaces of the specimen holders. These labels were quite useful when visually examining and photographing the numerous sets of specimens mounted within the specimen holders.

The environmental test chamber used for this study was an Associated Testing Laboratories Model HB-4108 cabinet. All test conditions (temperature, humidity and air flow/exchange rates) were preset and automatically controlled by the unit throughout the duration of the test exposure period. Documentation of the placement of the specimens and the specimen holders within the test chamber is provided in Figure 2. The position of each specimen holder within the chamber was changed after each of the three weekly visual inspections completed for the set of specimens. This was not a required procedure because the humidity and temperature within the 24 inch x 24 inch Plexiglas® chamber remained constant throughout the 1-month exposure period, and the exchange rate of the air within the chamber was minimal.
